**LEAD PAINT INSPECTION REPORT**

**Residence**  
**16571 B Street**  
**Victorville, Ca 92392**

**REPORT NUMBER:** S#01132- 08/25/14 11:05  
**INFOTOX#** 142124

**INSPECTION DATE:** August 25, 2014

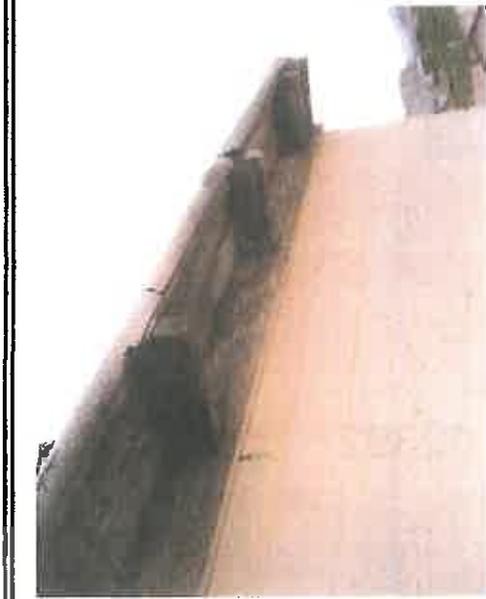
**PHOTO # 1**  
Soffit and Rafter

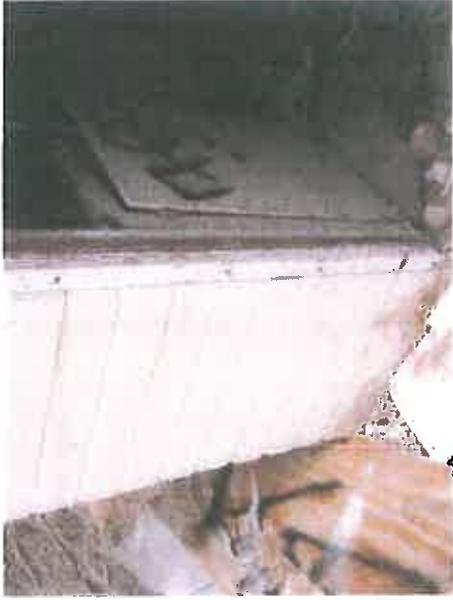
**PHOTO # 2**  
Door Jamb

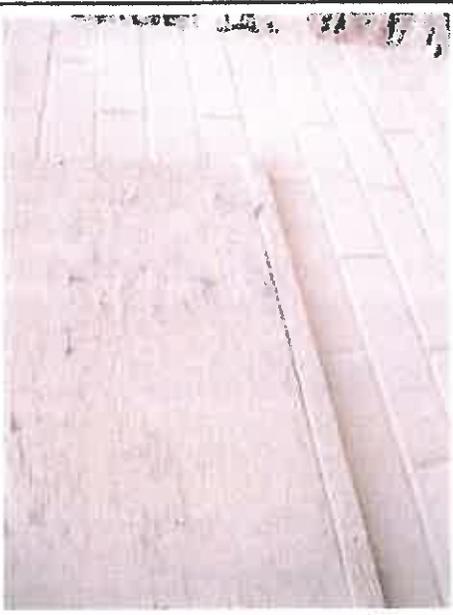
**PHOTO # 3**  
Window Sill

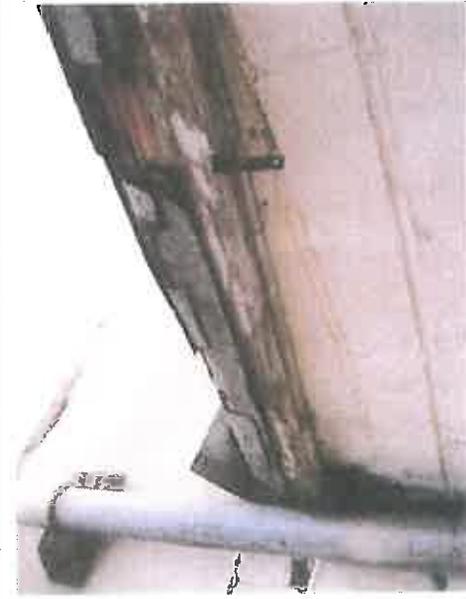
**PHOTO # 4**  
Fascia

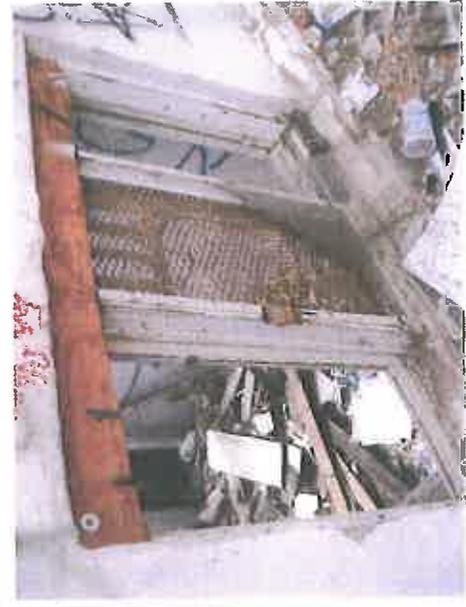
**PHOTO # 5**  
Window Sill, Casing, and Sash

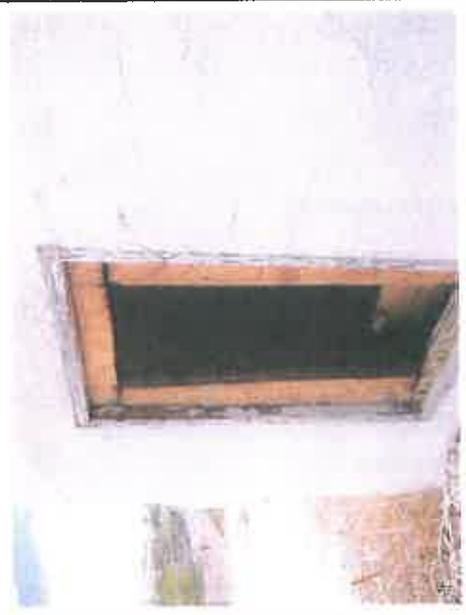
**PHOTO # 6**  
Window Casing

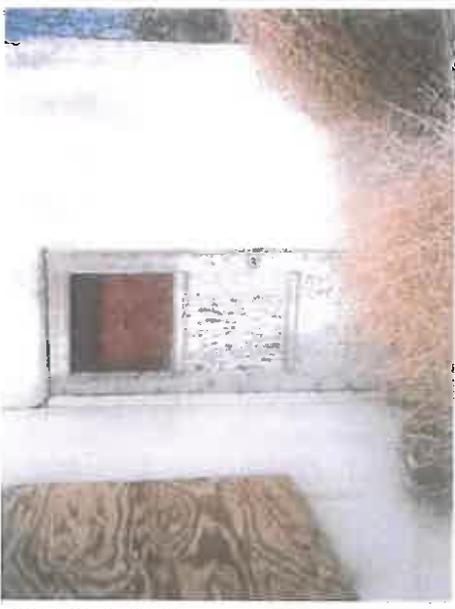
<p><b>PHOTO # 7</b> Door</p>	<p><b>PHOTO # 8</b> Fire Place and Mantle</p>	<p><b>PHOTO # 9</b> Tile Backsplash</p>

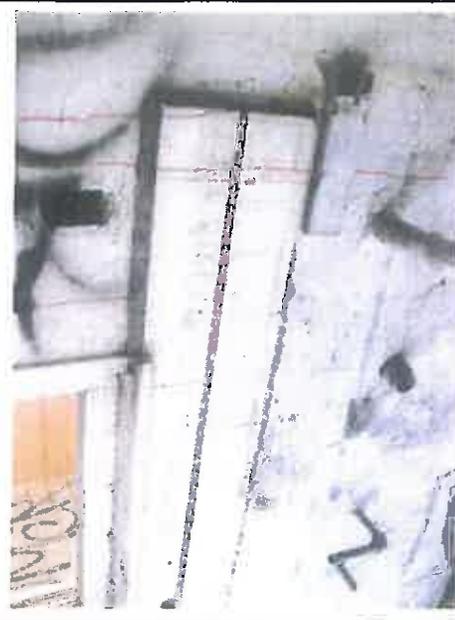
AREA 3 CONTAINS LEAD AT OR ABOVE THE HUD ACTION LEVEL. See tables under TAB 3 of this report for test locations.

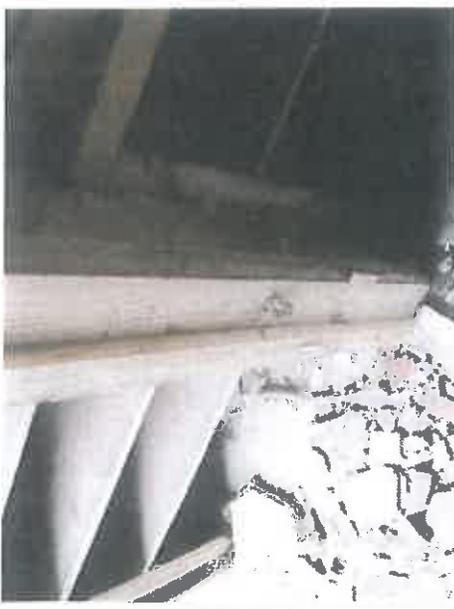
<p><b>PHOTO # 10</b> Door Casing and Jamb</p>	<p><b>PHOTO # 11</b> Window Casing and Sash</p>	<p><b>PHOTO # 12</b> Cabinet Side and Shelf</p>

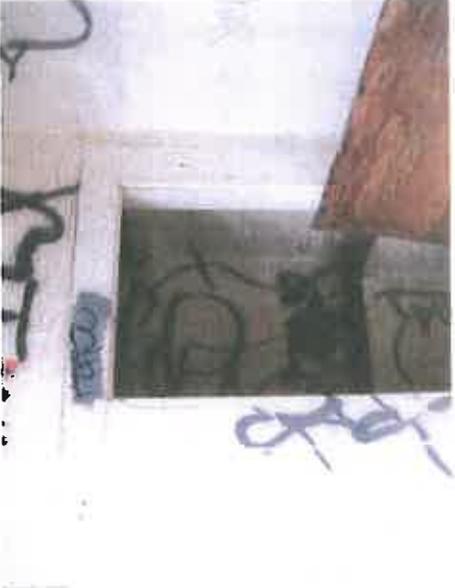
<p>PHOTO # 14 Closet Door Casing and Jamb</p>
