**LEAD PAINT INSPECTION REPORT**  
**FOR**  
**CITY OF VICTORVILLE**

**Residences**  
**15745 4<sup>th</sup> Street**  
**Victorville, Ca 92392**

**REPORT NUMBER:** S#01132- 07/7/14 06:02  
**INFOTOX#** 142120

**INSPECTION DATE:** July 7, 2014

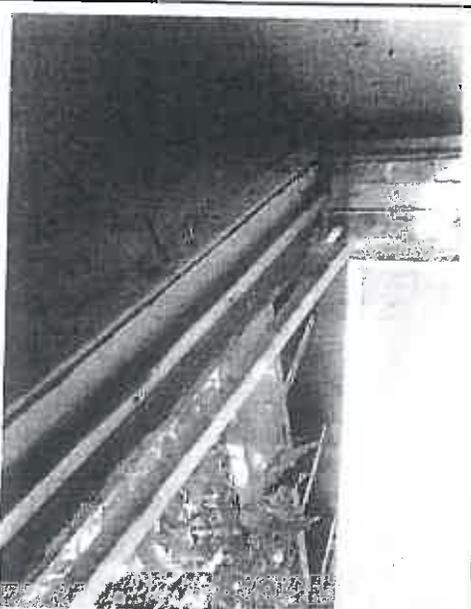
Door Jamb                      Wall (Per Laboratory Results)

<p>(Intentionally Left Blank)</p>
<p>PHOTO # 4 House 1 Door Jamb</p>	<p>PHOTO # 5 House 2 Rafter</p>	<p>PHOTO # 6</p>

It is our recommendation that all components that tested positive for the presence of lead at or above the HUD action level and any similar untested components be considered lead-laden. Any maintenance or repair activities on these components should be performed in an abatement/containment environment as required by Cal/OSHA Construction and Safety Orders, Lead Section 1532.1.

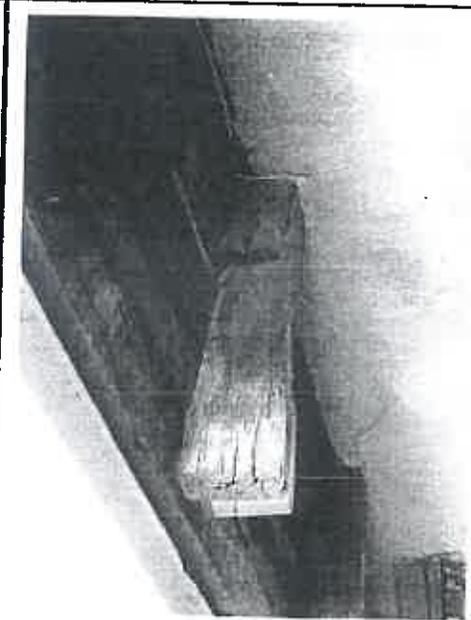
Rafter
