Subject: Residential Structures Asbestos Survey  
15131 Wildrose Street, Victorville  
Infotox, Inc. Project # 142142

On September 29, 2014, Infotox, Inc. performed asbestos surveys of the single story residential structure at 15131 Wildrose Street, Victorville, Victorville, CA.

The structure has fire damage and debris throughout.

# Site Diagram / Sample Collection Locations

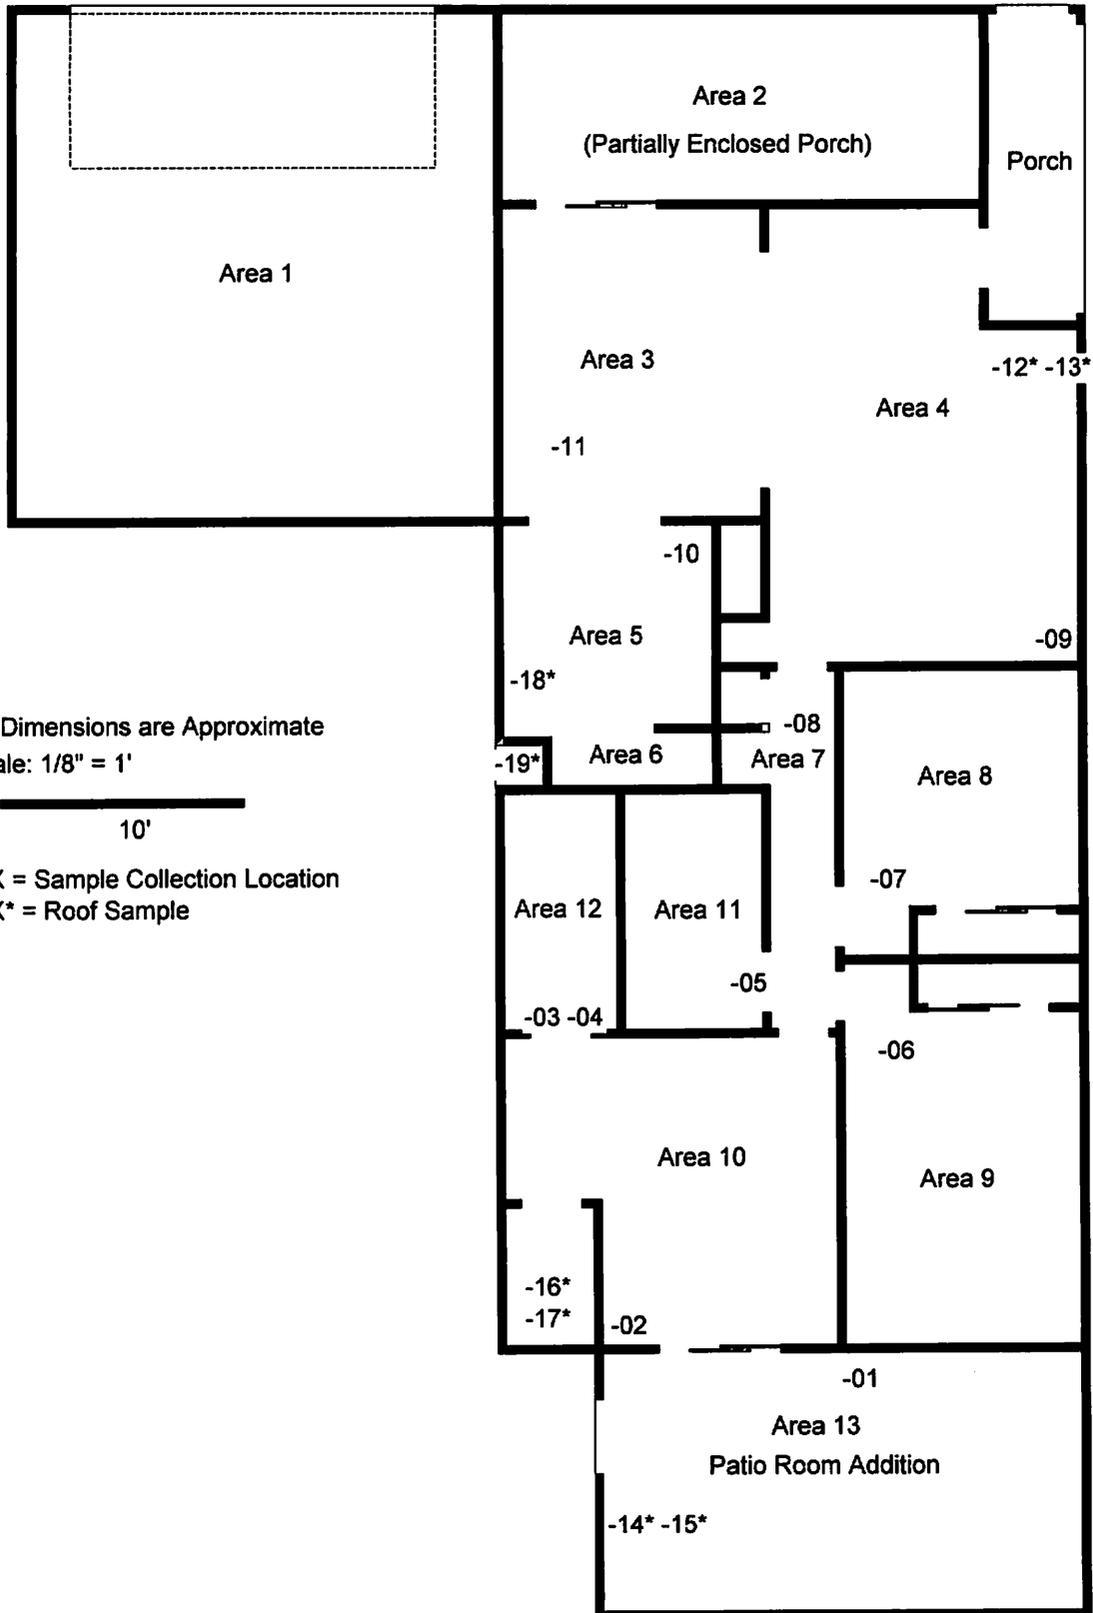
-XX = Sample Collection Location  
-XX\* = Roof Sample

15131 Wildrose Street, Victorville

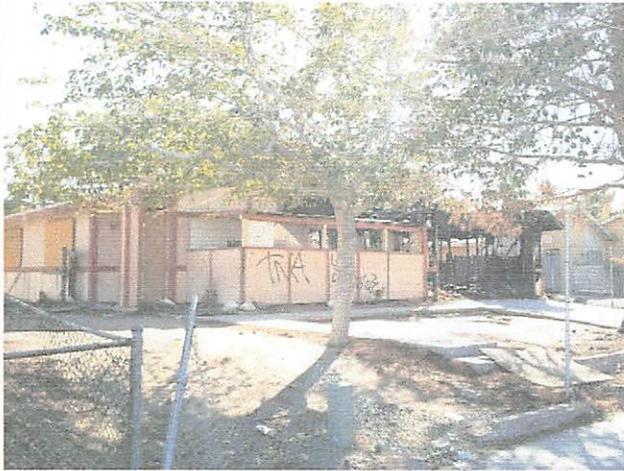
PHOTO # 1  
Sample(s): 15131-Note-01

PRI	SAMPLE	TYPE OF MATERIAL	TYP	%	COND	ACCESS	DIST	COMMENTS
----	-----	-----	---	-----	----	-----	----	-----
Area ID: 15131 WILDROSE plan/sheet ref N/A /B 1								
0	15131 NOTE01	PHOTOGRAPH ONLY		0.00	POOR	EASY	HIGH	PHOTO OF SINGLE STORY RESIDENCE @ 15131 WILDROSE, VICTORVILLE. FIRE DAMAGE & DEBRIS THROUGHOUT & AROUND.
0	15131 NOTE02	PHOTOGRAPH ONLY		0.00	FAIR	EASY	MOD	PHOTO OF TYPICAL WOOD LAMINATE FLOORING. OVER CONCRETE & VAPOR BARRIER/PAD IN AREAS 3,4,5,7,8,9,10.
0	15131-01	PAPER	ND	0.00	GOOD	SPECIAL	LOW	COLLECTED FROM AREA 13 NORTH WALL BLACK PAPER BEHIND EXTERIOR WOOD SIDING.
0	15131-02	DRYWALL AND JOINT COMPOUND	ND	0.00	POOR	EASY	HIGH	COLLECTED FROM AREA 10 SOUTH WALL WEST OF ENTRY. TYPICAL OF WALLS & CEILINGS THROUGHOUT
0	15131-03	GROUT	ND	0.00	FAIR	EASY	LOW	COLLECTED FROM AREA 12 FLOOR @ ENTR @ CERAMIC TILE. BROWN.
0	15131-04	MORTAR	ND	0.00	FAIR	EASY	MOD	COLLECTED FROM AREA 12 FLOOR UNDER CERAMIC TILE.

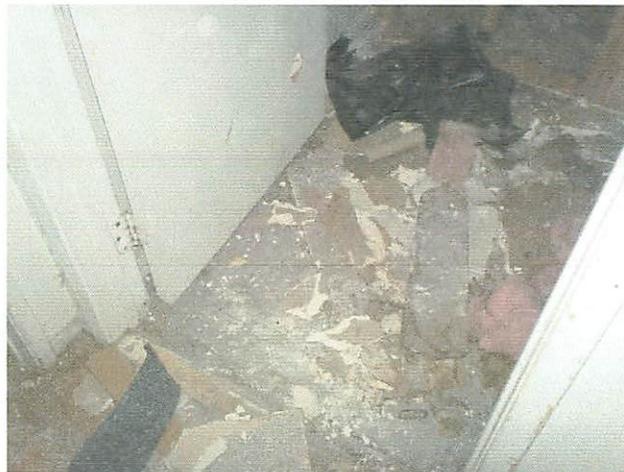
PHOTO # 5  
Sample(s): 15131-05

0	15131-05	12" FLOOR TILE	ND	0.00	GOOD	SPECIAL	LOW	COLLECTED FROM AREA 11 FLOOR @ ENTRY. WHITE SELF-STICK TILE.
0	15131-06	ACOUSTIC CEILING SPRAY	ND	0.00	POOR	OVERHEAD	HIGH	COLLECTED FROM AREA 9 CEILING @ N/W. AREA 3,4,7,8,9. -06,-07,-08 APPEAR TYPICAL.
0	15131-07	ACOUSTIC CEILING SPRAY	ND	0.00	POOR	OVERHEAD	HIGH	COLLECTED FROM AREA 8 CEILING @ S/W.
0	15131-08	ACOUSTIC CEILING SPRAY	ND	0.00	POOR	OVERHEAD	HIGH	COLLECTED FROM AREA 7 CEILING @ N/E.
0	15131-09	DRYWALL AND JOINT COMPOUND	ND	0.00	POOR	EASY	HIGH	COLLECTED FROM AREA 4 WALL @ S/E CORNER.

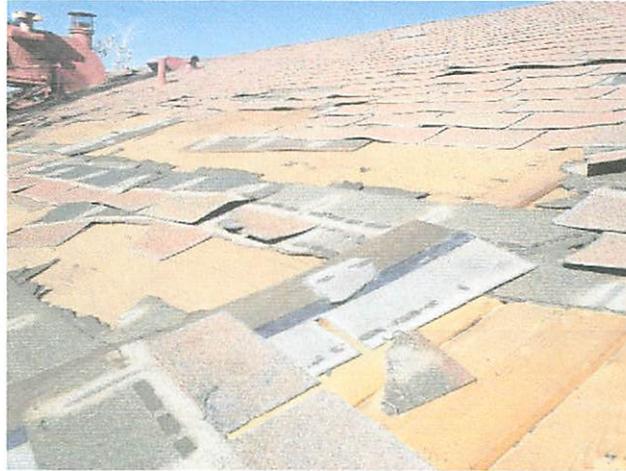
PHOTO # 14  
Sample(s): 15131-16, 17

PRI	SAMPLE	TYPE OF MATERIAL	TYP	%	COND	ACCESS	DIST	COMMENTS
0	15131-10	DRYWALL AND JOINT COMPOUND	ND	0.00	POOR	EASY	HIGH	COLLECTED FROM AREA 5 WALL @ N/E CORNER.
0	15131-11	FLOOR COVERING	ND	0.00	GOOD	SPECIAL	LOW	COLLECTED FROM AREA 3 FLOOR @ S/W. BELOW WOOD LAMINATE FLOORING. BLUE PLASTIC SHEETING W/ GREY PAD.
0	15131-12	ROOFING FELT	ND	0.00	POOR	SPECIAL	MOD	COLLECTED FROM ROOF @ N/E. BROWN COMPOSITION SHINGLE OVER -13 FELT. DEBRIS ON GROUND & INSIDE HOUSE.
0	15131-13	ROOFING FELT	ND	0.00	POOR	SPECIAL	MOD	COLLECTED FROM ROOF BELOW -12 SHINGLE.
0	15131-14	ROOF MASTIC	ND	0.00	GOOD	SPECIAL	LOW	COLLECTED FROM AREA 13 ROOF @ WEST CENTER. FOIL W/BLACK MASTIC @ SEAMS OF METAL.
0	15131-15	ROOF MASTIC	ND	0.00	GOOD	SPECIAL	LOW	COLLECTED FROM AREA 13 ROOF @ WEST CENTER. WHITE FLEXIBLE MASTIC @ FASTENERS ON METAL ROOF.
0	15131-16	ROOF MATERIAL	ND	0.00	POOR	SPECIAL	MOD	COLLECTED FROM ROOF @ S/W. APPEARS TYPICAL OF -12 SHINGLE.

0	15131-17	ROOFING FELT	ND	0.00	POOR	SPECIAL	MOD	COLLECTED FROM ROOF @ S/W. APPEARS TYPICAL OF -13 FELT PAPER.
4	15131-18	ROOF MASTIC	C	8.00	FAIR	SPECIAL	LOW	COLLECTED FROM ROOF @ N/W @ HVAC PIPING FLASHING. GREY/BLACK. FLASHINGS & PENETRATIONS. APPROX 10 SFT.
4	15131-19	ROOF MASTIC	C	8.00	FAIR	SPECIAL	LOW	COLLECTED FROM ROOF @ N/W @ VENT PIPE PENETRATION. APPEARS TYPICAL OF -18. SEE -18 FOR QUANTITY.

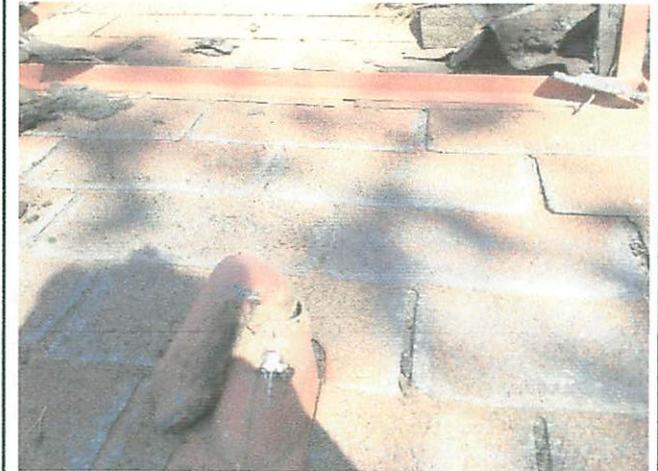
PHOTO # 15  
Sample(s): 15131-18

Sample	Description	Appearance	Non-Asbestos		Asbestos
			% Fibrous	% Non-Fibrous	% Type
15131-12 321417909-0012	ROOF MATERIAL	Brown/Black Fibrous Heterogeneous	15% Glass	85% Non-fibrous (other)	None Detected
15131-13 321417909-0013	ROOF FELT	Black Fibrous Heterogeneous	30% Cellulose	70% Non-fibrous (other)	None Detected
15131-14 321417909-0014	ROOF MASTIC	White Non-Fibrous Homogeneous		100% Non-fibrous (other)	None Detected
15131-15 321417909-0015	ROOF MASTIC	Black/Silver Non-Fibrous Heterogeneous		100% Non-fibrous (other)	None Detected
15131-16 321417909-0016	ROOF MATERIAL	Brown/Black Fibrous Heterogeneous	10% Glass	90% Non-fibrous (other)	None Detected
15131-17 321417909-0017	ROOF FELT	Black Non-Fibrous Homogeneous	30% Cellulose	70% Non-fibrous (other)	None Detected
15131-18 321417909-0018	ROOF MASTIC	Red/Black Fibrous Heterogeneous		92% Non-fibrous (other)	8% Chrysotile
15131-19 321417909-0019	ROOF MASTIC	Brown/Black Fibrous Heterogeneous		92% Non-fibrous (other)	8% Chrysotile

EPA (NESHAP) and Mojave Desert Air Quality Management District (MDAQMD) regulations require that asbestos containing materials be removed from a structure prior to demolition or renovation activities that may disturb the materials.

Asbestos related work must be performed by California Licensed and Registered Asbestos Abatement Contractors. Limited exceptions to this requirement are allowed by various regulatory agencies. Infotox, Inc. recommends that only California Licensed and Registered Asbestos Abatement Contractors be utilized to perform asbestos related work.
