Infotox, Inc.
A California Corporation

Subject: Residential Structure Asbestos Survey
14499 Turner Road, Victorville, CA
Infotox, Inc. Project # 142123

On September 18, 2014, Infotox, Inc. performed asbestos surveys of the two single story residential structures and pool located at 14499 Turner Road, Victorville, CA

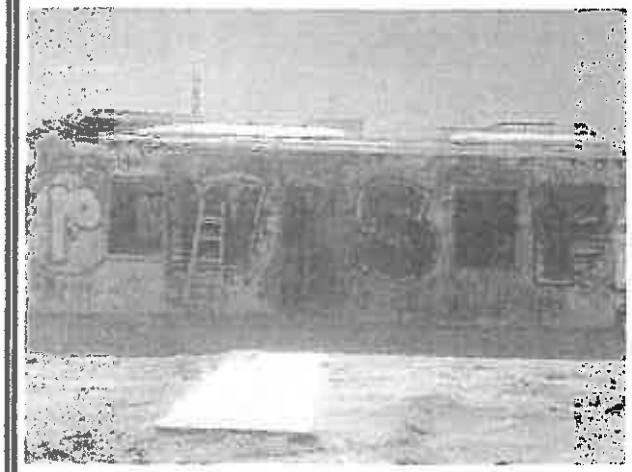
PHOTO # 1
Sample(s): 1 Note-01

PRI	SAMPLE	TYPE OF MATERIAL	TYP	%	COND	ACCESS	DIST	COMMENTS
Area ID: 14499 TURNER, STRUCTURE 1 plan/sheet ref N/A /B 1								
0	1 NOTE-01	PHOTOGRAPH ONLY		0.00	POOR	EASY	HIGH	PHOTO OF STRUCTURE 1(EAST STRUCTURE). WOOD FRAMED STUCCO ON SLAB. DAMAGE & DEBRIS ARE THROUGHOUT & AROUND.
0	1-01	FLOOR TILE MASTIC	ND	0.00	GOOD	EASY	LOW	COLLECTED FROM AREA 2 FLOOR @ N/W. BLACK MASTIC ON CONCRETE. FROM PAST 9" TILE. AREAS 1, 2, 3, 4.
0	1-02	WALL PLASTER	ND	0.00	POOR	EASY	HIGH	COLLECTED FROM AREA 5 WEST WALL. TYPICAL OF WALLS THROUGHOUT. STUCCO TEXTURE PLASTER. DAMAGE & DEBRIS.
0	1-03	PAPER	ND	0.00	POOR	EASY	HIGH	COLLECTED FROM AREA 5 WEST WALL BEHIND -02 PLASTER.
1	1-04	DRYWALL AND JOINT COMPOUND	C	2.00	POOR	OVERHEAD	HIGH	COLLECTED FROM AREA 1 CEILING @ EAST CENTER. DAMAGE & DEBRIS. ASBESTOS DETECTED IN JOINT COMPOUND. APPROX. 500 SFT.
0	1-05	FLOOR TILE MASTIC	ND	0.00	GOOD	SPECIAL	LOW	COLLECTED FROM AREA 1 FLOOR @ N/W CORNER. APPEARS TYPICAL OF -01.

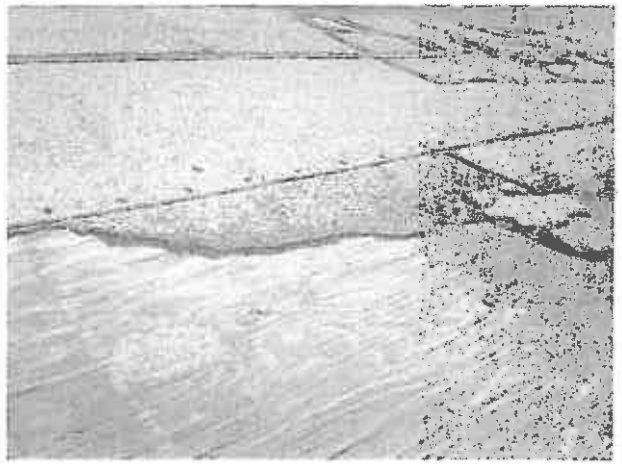
PHOTO # 26
Sample(s): 2-09, 10

0	2-07	STUCCO	ND	0.00	POOR	EASY	MOD	COLLECTED FROM WEST EXTERIOR WALL NORTH OF AREA 6.
1	2-08	ROOF MASTIC	C	15.00	POOR	SPECIAL	MOD	COLLECTED FROM ROOF @ WEST CENTER VENT PIPE. TYPICAL OF 3. APROX 2 SFT.
0	2-09	ROOF MATERIAL	ND	0.00	POOR	SPECIAL	MOD	COLLECTED FROM ROOF @ WEST CENTER. WHITE ROLLED ROOFING.
0	2-10	ROOFING FELT	ND	0.00	POOR	SPECIAL	MOD	COLLECTED FROM ROOF @ WEST CENTER. BELOW -09 ROOFING.
